# 4 Capitol Square Complex Buildings

## Existing Building Analysis

VIRGINIA STATE CAPITOL MASTER PLAN

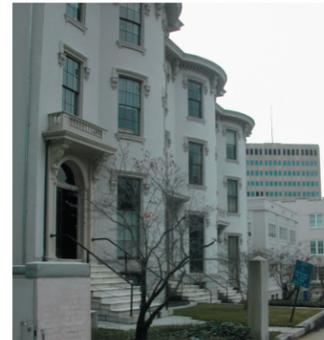
Fig. 4-13 Morson's Row Buildings

The Morson's Row townhouses are on the National Register of Historic Places and the Virginia Landmarks Register. Built in 1848 as rental properties, they are the only evidence of the historic neighborhood that once surrounded Capitol Square. The building areas are not suited for large offices. All three buildings—219, 221, and 223 Governor Street—need their HVAC systems replaced. The Morson's Row townhouses along with the Aluminum and Zincke buildings could be served very efficiently by a single hot water/chilled water plant.

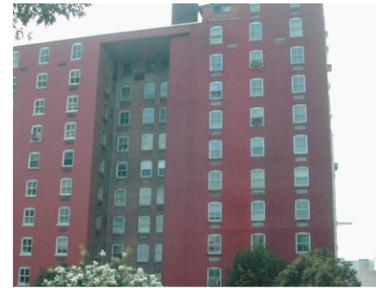
Fig. 4-17 Typical existing upper floor plan of the Eighth Street Office Building

Originally constructed in 1912 as the Murphy Hotel, the 12-story Eighth Street Office Building was converted for office use. The building is 92 years old with a typical floor plate size of 6,690 NASF. The small floor plate area makes the building inefficient for space utilization. Smaller floor plate size also makes a single floor inadequate for an agency with high space requirements. Twelve floors of the building are currently occupied by five different agencies. The NASF per FTE staff ratio of this building is among the highest (447) compared to the 210- or 250-NASF/FTE standard.

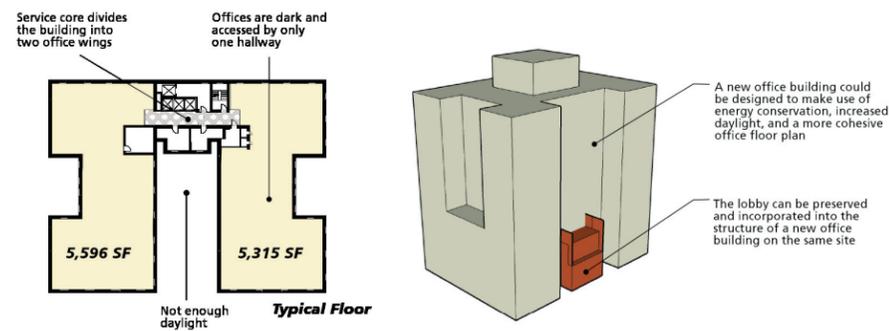
Fig. 4-20 New replacement office building alternative preserving the historic lobby

The building's original 2-story Richmond Hotel lobby is in good condition and unique for the existing office building use. Fig. 4-20 shows an alternative that preserves the lobby and also increases the floor plate size to approximately 17,000 NASE. It would be useful to have a feasibility study of the building structure exploring such an option. DGS is also considering the Ninth Street Office Building under the PPEA.

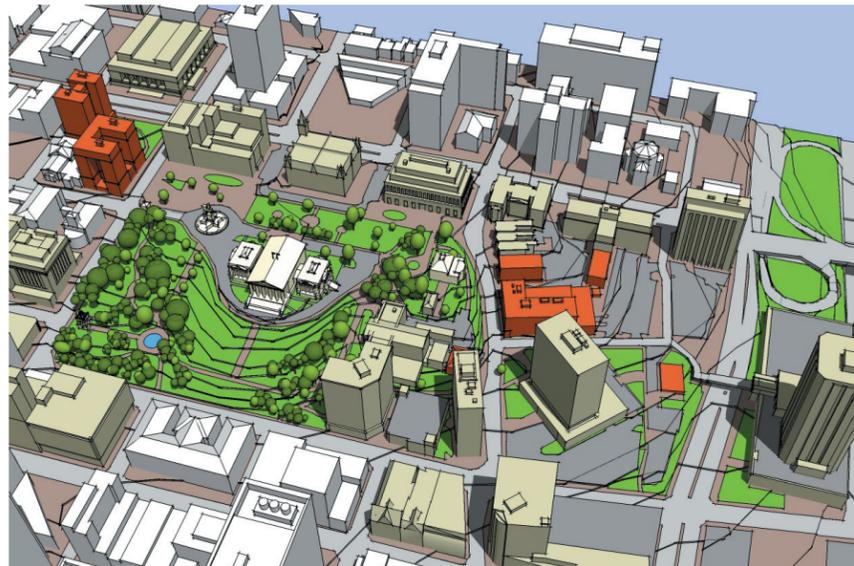
Fig. 4-28 3D model view of the existing structures shown in orange proposed for demolition/relocation

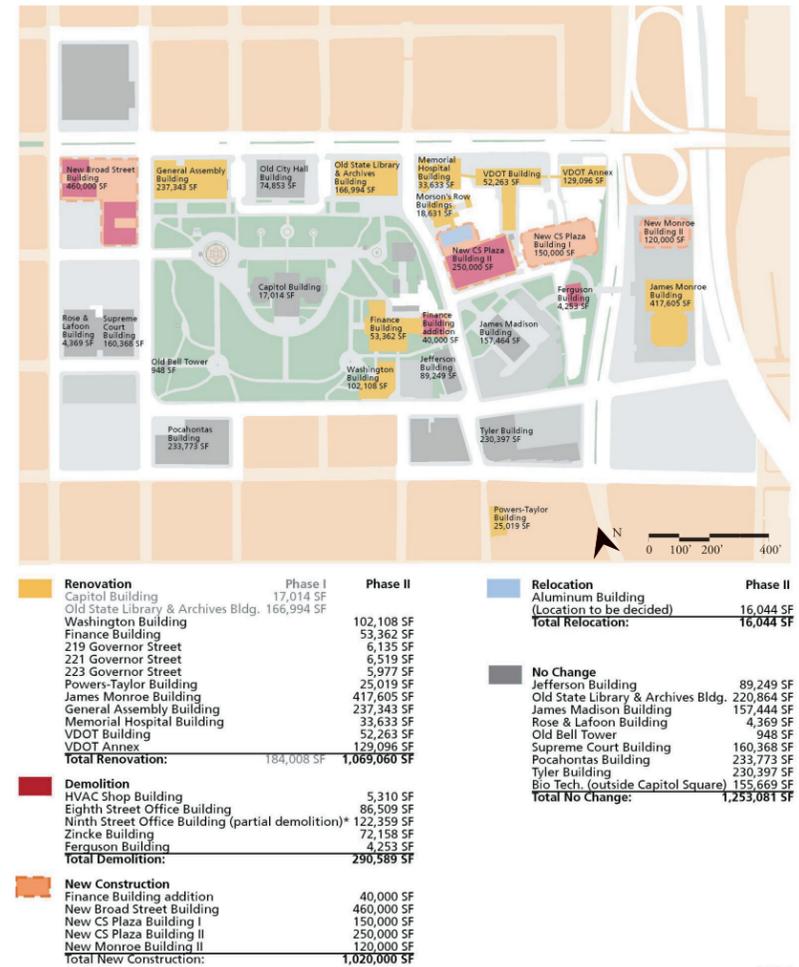
Fig. 4-30 Summary of building recommendations

Three or four new buildings totaling an area of approximately 502,000 NASF would accommodate this new space need. Figure 4-30 shows one such maximum new space and renovation scenario and summarizes all the master plan building recommendations.
